Solar PV Installations on Asbestos Cement Sheet Roofs

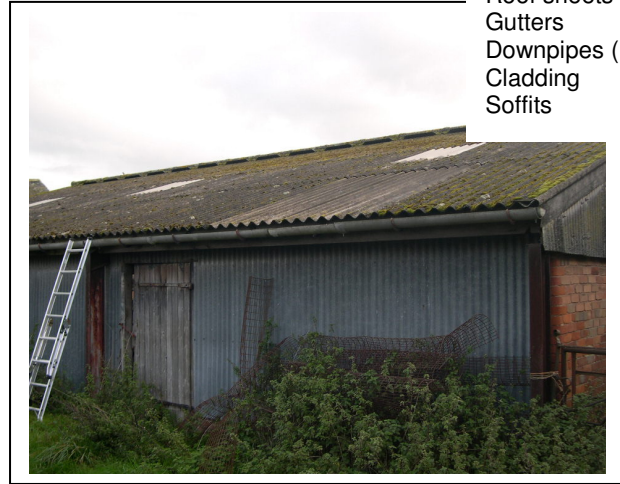
Asbestos may be found in:
Ridge line
Roof sheets
Gutters
Downpipes (not shown)
Cladding
Soffits

Many farm and industrial buildings have profile cement sheeting. These could contain asbestos, indeed older ones are likely to contain asbestos. Asbestos was banned in 1999 so in theory any building from before this time could contain asbestos, but we have also found a building constructed in 2004 that had an asbestos cement sheet roof, clearly from an illegally stored supply that should never have been used, but this illustrates the uncertainty. Apart from the roof sheets, asbestos is also likely to be present in the ridge line, gutters, downpipes and soffits and may have been used for wall cladding.
